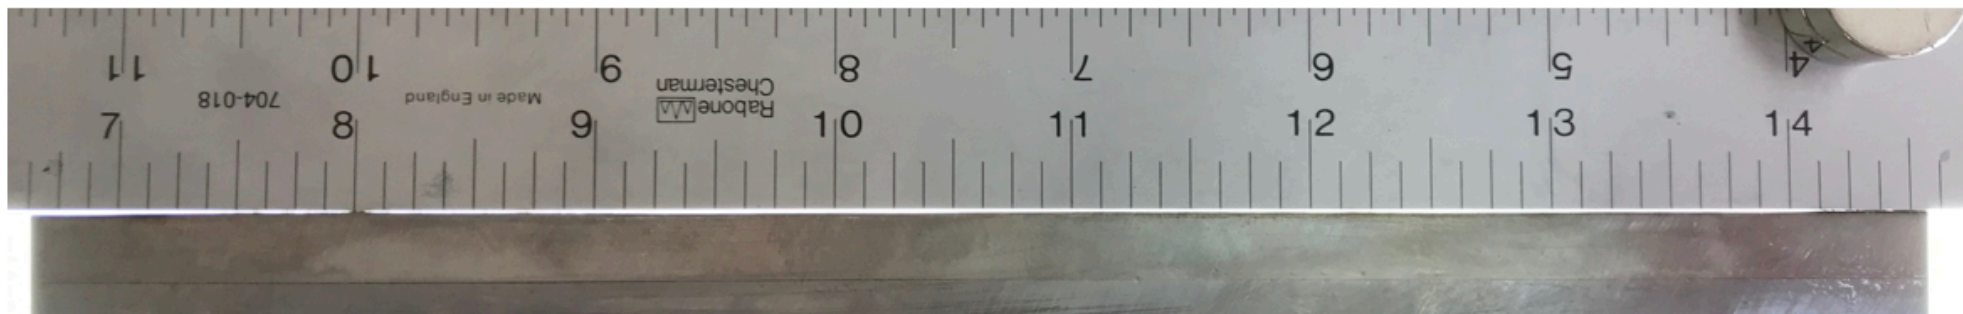
As received from Sharpening shop
